Inspection News & Views from the American Society of Home Inspectors, Inc.

VERMICULITE in the Attic p.10

A WORSE-CASE SCENARIO — that's what I found in the attic of a home I recently inspected. Although this wasn't the first time I found evidence that some contractors have no clue about how to work around attic insulation, this time qualified as a worsecase scenario because the insulation was vermiculite.

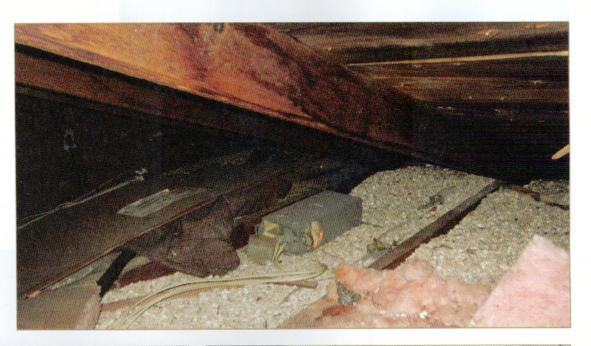
From the attic hatch's pull-down stairs, I photographed the bath fan (see photo at right), which had been blowing the product around the attic for years. Knowing how poorly hatches with pull-down stairs seal, I identified this as one path for asbestos being released into the living space.

I assume the homeowner and the contractor had been equally unaware of the health risks presented by vermiculite and of how it should be handled. Because my client still was interested in the property, I advised him to consult a professional remediation contractor. Nevertheless, even when informed, the owner did not want to address the issues, so my client moved on.

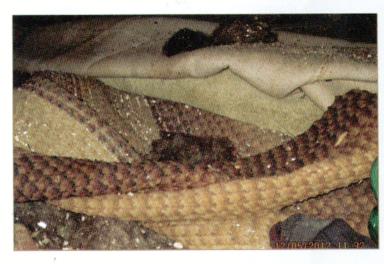
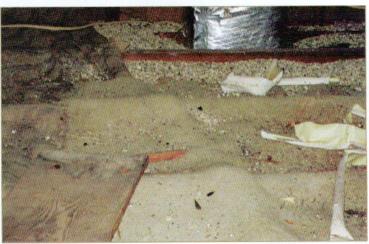
To make matters worse, fabric and carpets had been tossed in the attic, as you can see in the four photos above. Vermiculite can be seen under and on top of the debris. It will have to be disturbed further to remove the fabric and debris.

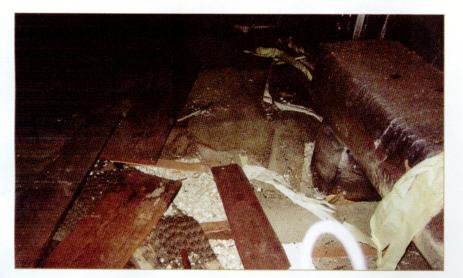
The air conditioning duct (on the right in the photo at left) was installed through the ceiling and down into a closet. No measures were taken to contain the vermiculite, and it has spilled into the living space another path for contamination.

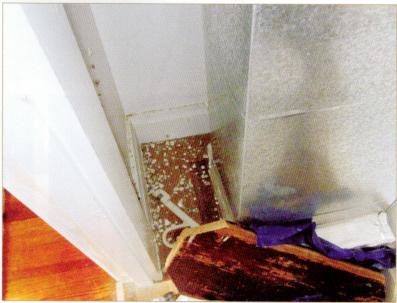
In the photo at the right, you can see where vermiculite has fallen out of the ceiling because an AC duct was installed.

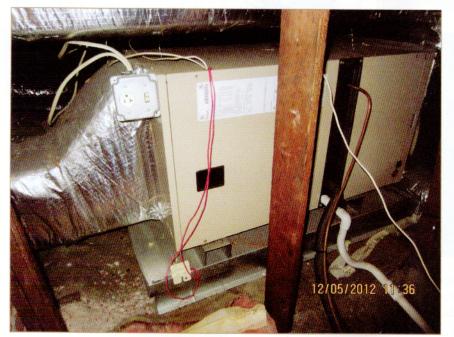
And, what may be the worst in this worsecase scenario, the air handler in the attic is sitting in and on vermiculite. I observed vermiculite inside the return duct, leading me to believe that asbestos probably is being blown through the air into the house every time the blower runs — yet another path.
